## **Development and Implementation of a Risk Mitigation Strategy to Mine a Primary-Secondary Production Stope in a High-Stress Environment at VALE Creighton Mine**

**ABSTRACT:** Safe extraction of the valued ore resource in the deep levels of VALE Creighton Mine has progressed in a pillar-less fashion using vertical retreat, slot-slash and uppers retreat methods since the cessation of ‘cut and fill’ mining in the late 1980’s. Sequencing of the panel extraction and filling has been the key to successful exploitation of high stress orebodies at depth.

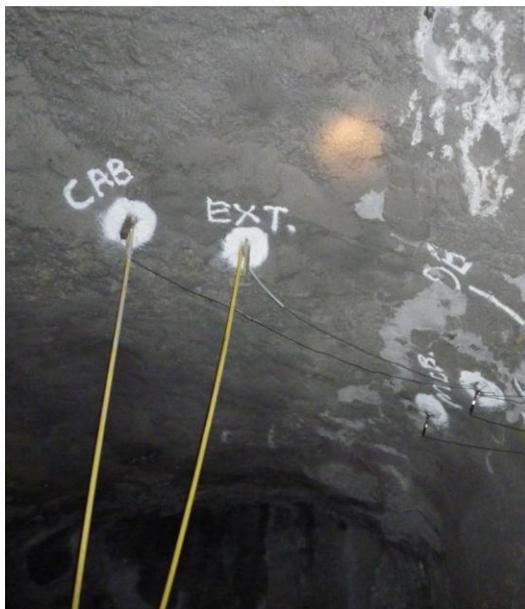
The instrumentation project was conducted during the mining of the 4368 primary stope to 6730 bottomsill until the point that mining of the hangingwall section cut-off access to instrumentation and preparation for mining of the secondary stope prompted removal of the pressure cells at the 4408 topsill. Instruments were installed in three locations in and around the secondary pillar as shown in figure 5.

**Figure 5– 6770 Oresill Instrumentation ‘squeeze’**

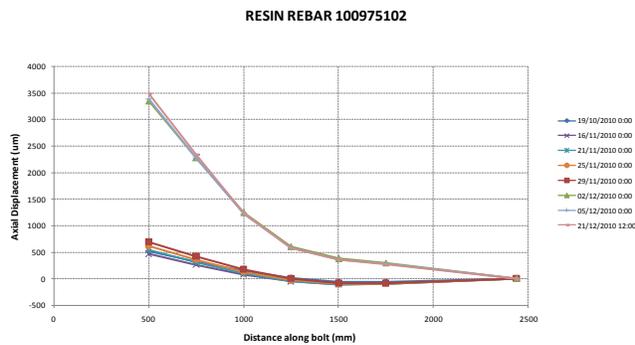
Thereafter, the yielded sections (highest profiles in figure 9) exhibit progressive creep whereas the elastic sections of the bolt towards the toe of the hole do not. As indicated by figure 10, the highest load/strains were measured closest to the plate: the yield strength of the steel being exceeded over a 1m length. The corresponding end to end stretch of the rebar is 3.5 mm (figure 11).

Figure 11: Stretch along the resin rebar
